# Manhole Inspection Summary

Manhole # S65Q\_\_014MH

**Location** Address: **1412 Broening Hwy.**

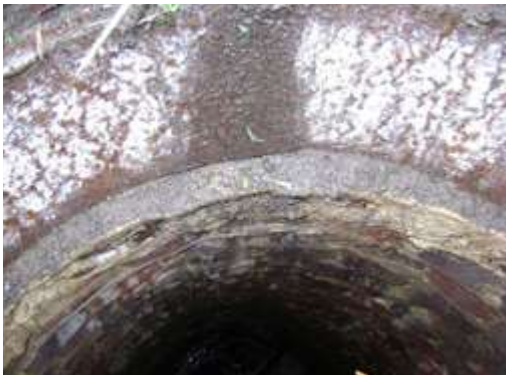
Defect 2

**Frame** Offset: **1** (in.) Condition: ☒ Sound ☐ Cracked ☐ Leaks

Offset frame

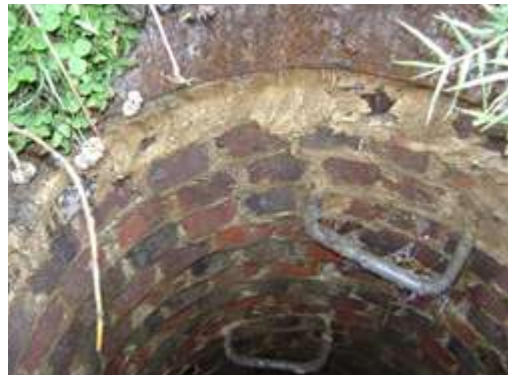
Defect 1

Condition: ☐ Sound ☐ Cracked ☐ Root Intrusion ☐ Loose Brick ☒ **Deteriorated**

Infiltration: ☐ None ☒ **Joint** ☐ Cracks ☒ **Mortar** ☐ Roots ☐ Wall

previous repair at frame adjustment

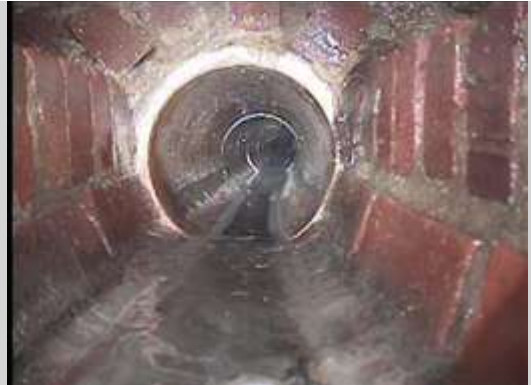
12 O'Clock Outflow

8 in. Circular Gravity Sewer  
Pipe Out @ 12 O'Clock

Pipe Height: **8.4** (in.) Rod and Bar (Angled)  
Pipe Material: **Clay** ☐ Pipe Lined  
Invert Depth: **6.67** (ft.) Flow Characteristics: **Slow**  
Deposits: ☒ None ☐ Mud ☐ Sludge ☐ Debris ☐ Grease  
Silt Depth: (in.) Deposits Extent:  
Infiltration: **None** Pipe Seal Cond: **Sound**

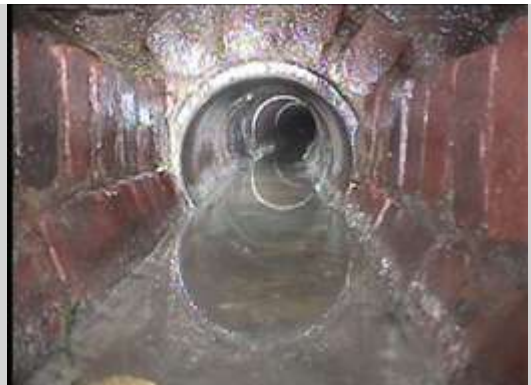
6 O'Clock Inflow

8 in. Circular Gravity Sewer  
Pipe In @ 6 O'Clock

Pipe Height: **8.4** (in.) Rod and Bar (Angled)  
Pipe Material: **Clay** ☐ Pipe Lined  
Invert Depth: **6.58** (ft.) Flow Characteristics: **Slow**  
Deposits: ☒ None ☐ Mud ☐ Sludge ☐ Debris ☐ Grease  
Silt Depth: (in.) Deposits Extent:  
Infiltration: **None** Pipe Seal Cond: **Sound**
